Manhole Inspection Summary

Manhole # S43K2_008MH

Insp Date: **4/29/08 2:54 PM**

Location Address: **1100 Church St.**

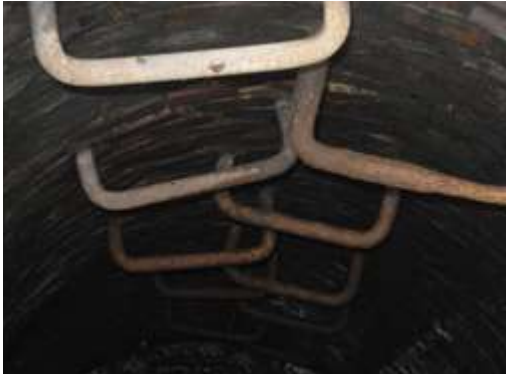
Count: **9** Missing: **0** ☒ **Corroded**

Steps

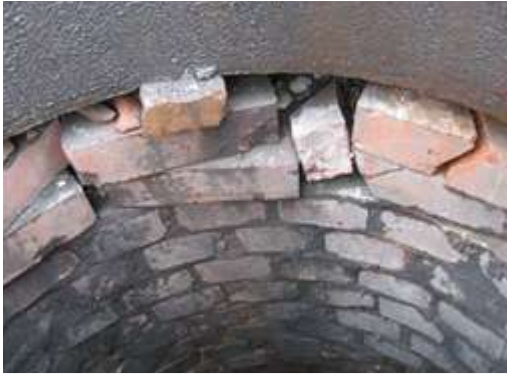
Defect 1

Condition: ☐ Sound ☐ Cracked ☐ Root Intrusion ☒ **Loose Brick** ☒ **Deteriorated**

Infiltration: ☐ None ☒ **Joint** ☐ Cracks ☒ **Mortar** ☐ Roots ☒ **Wall**

Chimney (Loose bricks)

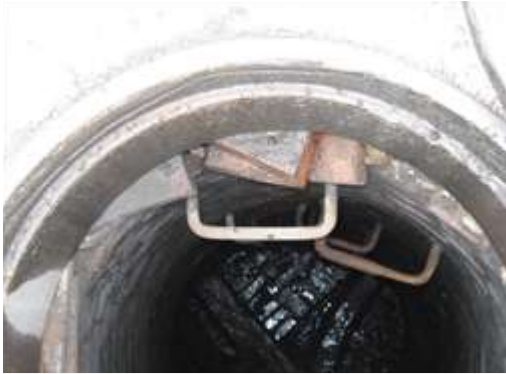
Defect 2

Offset: **2** (in.)

Frame Offset

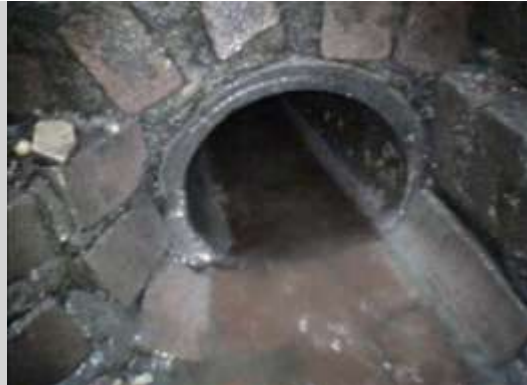
12 O'Clock Outflow

8 in. Circular Gravity Sewer
Pipe Out @ 12 O'Clock

Pipe Height: **8.4** (in.) Rod and Bar (Angled)
Pipe Material: **DIP/CI** ☐ Pipe Lined
Invert Depth: **16.38** (ft.) Flow Characteristics: **Fast**
Deposits: ☒ None ☐ Mud ☐ Sludge ☐ Debris ☐ Grease
Silt Depth: (in.) Deposits Extent:
Infiltration: **None** Pipe Seal Cond: **Sound**

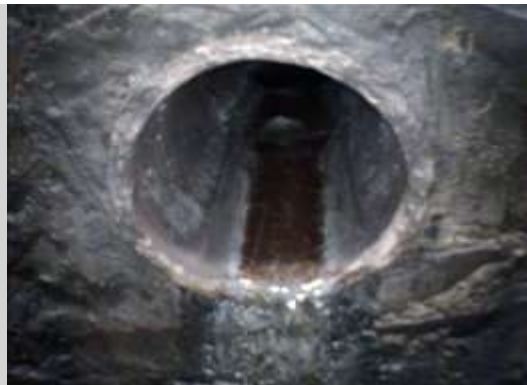
3 O'Clock Inflow

8 in. Circular Gravity Sewer
Pipe In @ 3 O'Clock

Pipe Height: **8.4** (in.) Rod and Bar (Angled)
Pipe Material: **Clay** ☐ Pipe Lined
Invert Depth: **11.64** (ft.) Flow Characteristics: **Fast**
Deposits: ☒ None ☐ Mud ☐ Sludge ☐ Debris ☐ Grease
Silt Depth: (in.) Deposits Extent:
Infiltration: **None** Pipe Seal Cond: **Sound**

Drop: **Outside** Rod and Bar
Angled: **Yes** Reading: **15.02** (ft.)
Inv Depth: **16.02** (ft.)

Drop Condition: **Open**

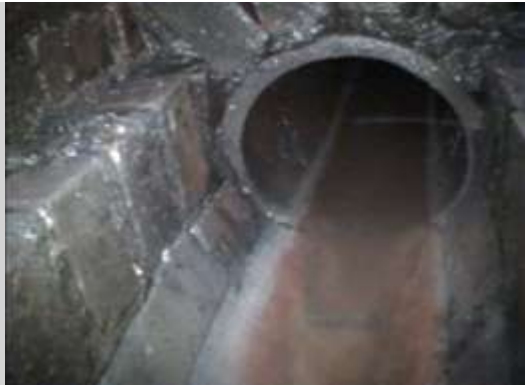
6 O'Clock Inflow

Pipe In @ 6 O'Clock

Pipe Height: **8.4** (in.) Rod and Bar (Angled)

Pipe Material: **Clay** ☐ Pipe Lined

Invert Depth: **16.16** (ft.) Flow Characteristics: **Fast**

Infiltration: **None** Pipe Seal Cond: **Sound**

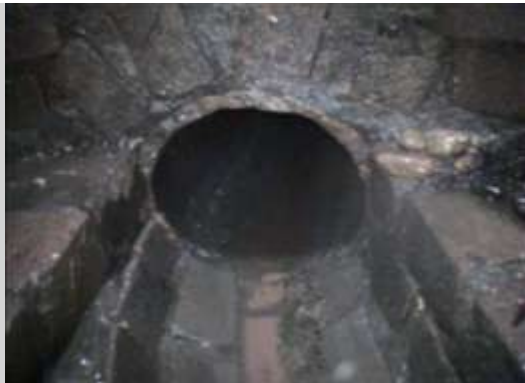
9 O'Clock Inflow

Pipe In @ 9 O'Clock

Pipe Height: **8.4** (in.) Rod and Bar (Angled)

Pipe Material: **Clay** ☐ Pipe Lined

Invert Depth: **16.16** (ft.) Flow Characteristics: **Slow**

Infiltration: **None** Pipe Seal Cond: **Sound**
